Murena *mechanics*

Replacing Headlamps

Espace

examined

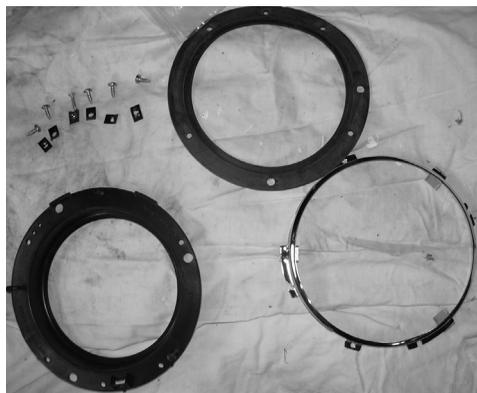
The kit (*below left*) comprises a mounting body, a rubber gasket, a chrome bezel to hold the lamp unit, five self-tapping screws and dished spire nuts, and an instrument head self-tapper and a gold spire nut. The latter two items are provided to fit an external trim ring so are not required in this application.

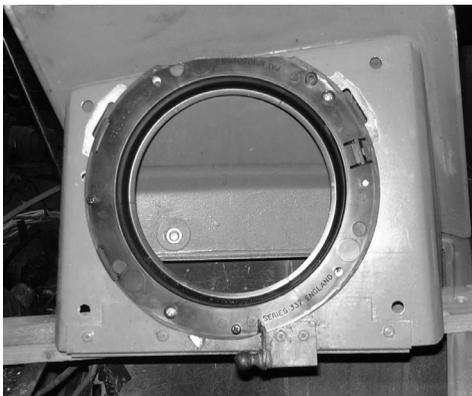
It was at this stage I discovered a snag. The mounting body is designed to mount the lamp with two adjusters at twelve o'clock and nine o'clock for vertical and lateral adjustment and a fixed mounting at four o'clock. However, the sharp angle of the headlamp pod means that there is no room for the top adjuster. The bezel is designed so that the lamp can only be fitted on one position, but fortunately has provision for the vertical adjustment to be at either the top or the bottom. After a lot of head scratching and trial fitting, I decided that the solution was to turn the body 90 degrees anti-clockwise, providing adjustment at

nine o'clock and six o'clock. This would make the vertical adjustment a little tricky to reach, but the original lamps had an adjuster there, so I reckoned it would be all right.

To fit the body, I drilled an 8mm hole for each of the adjusters and offered it up to the pod. I had to shave a small segment off the top of the body and the gasket. (*see below*) That done, I could again offer the mounting body up to the pod and drill a series of 4mm holes to fix the body to the pod, using the self-tappers and the dished spire nuts. The holes are already provided in the body and the gasket. I also had to cut a small notch to clear the raising bracket.
