# Murena

### **Bosch Reluctor problem**

This technical article **only** applies to the Murena 2.2 and the Type 180 engine with the original Bosch electronic distributor. That's Bosch part number 0.237.002.069 which is stamped in the body side with an arrow indicating clockwise rotation as seen from above.

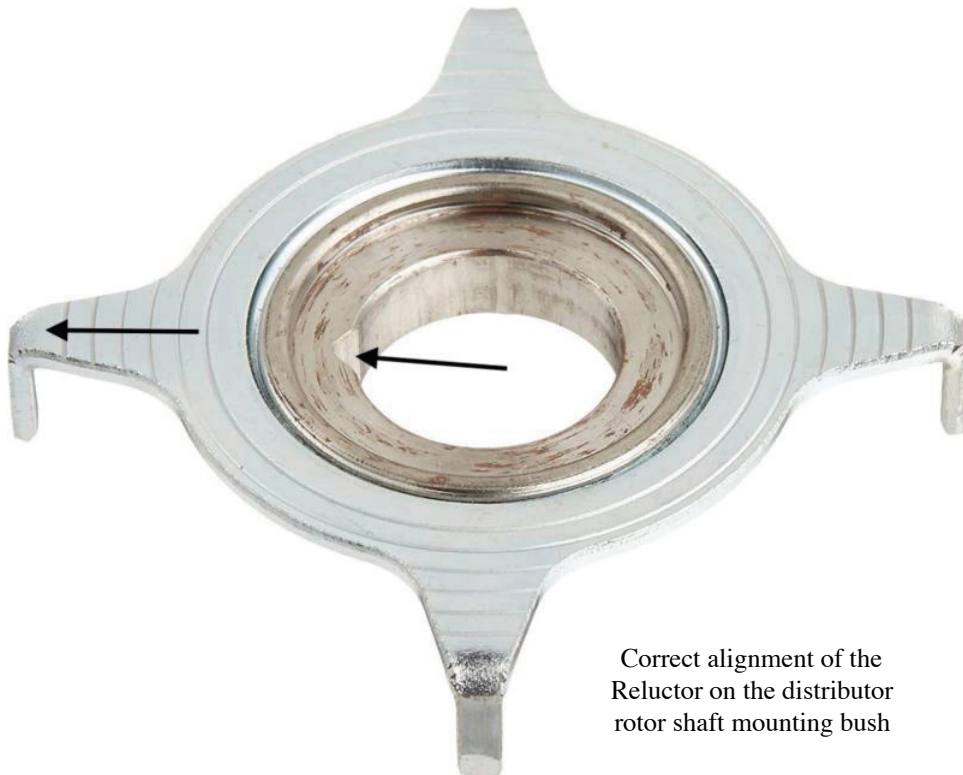
Correct alignment of the Reluctor on the distributor rotor shaft mounting bush

To check it, all that is needed is to remove the distributor cap, rotor arm and the flash shield if that is still fitted, and look carefully at the relationship of the four Reluctor 'fingers' in relation to the groove in the bush it is press fitted on to, as in the photo on the previous page, of a new Reluctor. One Reluctor finger should be in line with that groove in the bush, as indicated by the two black arrows in the photo.

Once out, you can realign the groove to the correct position, but it will probably need the assembly warming first as the Reluctor will probably still be tight and difficult to move when cold. It doesn't have to be in an exact position on the bush as long as the finger is roughly central to the groove as in the photo of the new one on page 1.

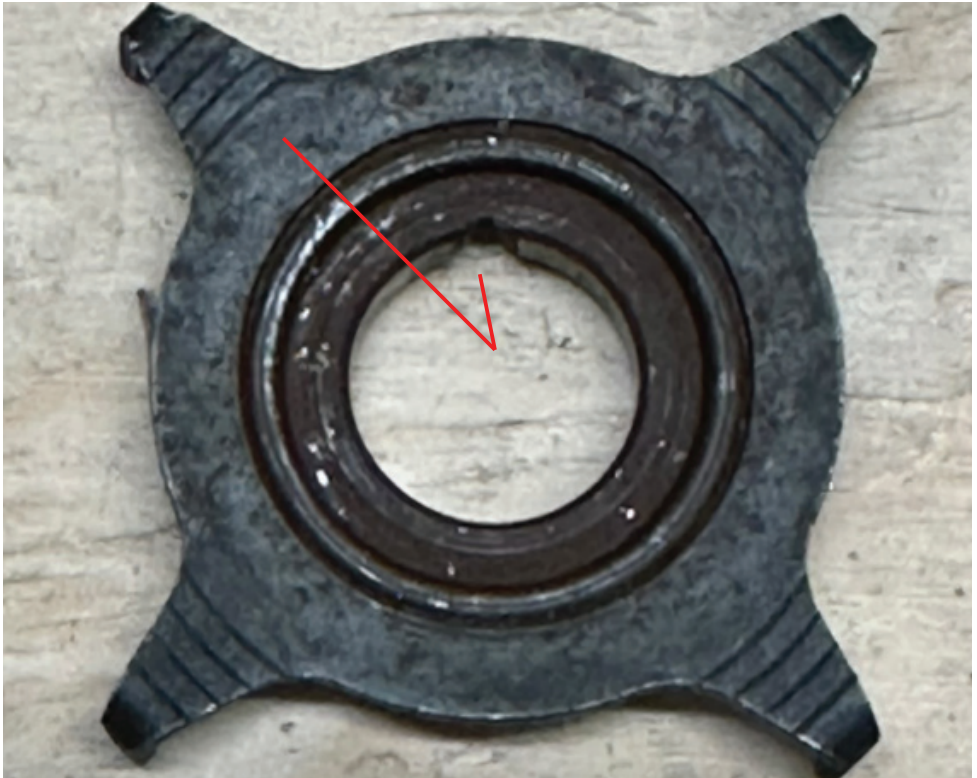
the H.T. Lead to a spark plug. If the Reluctor has moved out of position, then when it triggers the coil to fire a plug, the rotor arm will no longer be correctly aligned with the distributor cap segments, and the pulse will have to jump to the segment, losing some of its energy and the spark at the plug will be much weaker as well as late.

The photo on page 2 and this one on page 3 show a Reluctor that is out of

position on its mounting bush, because it has rotated over a period, and this means the rotor arm will not be close to a cap segment, when it triggers the coil. In the photo on this page the rotor arm is close to where a distributor cap segment would be, but if you look at the Reluctor fingers, they are nowhere near the stationary ones, so it is nowhere near the timing/firing point.

To get the alignment back, the bush and Reluctor need to be removed from the distributor, by removing that tiny circlip and prising the bush up off the rotor shaft. Be careful to retain the small locking pin as that will be needed when refitting it, to lock the bush correctly to the rotor shaft.

Once the Reluctor is in the correct place on the bush, then you need to lock it in place to prevent it moving again. And I would also mark it across from the bush to the Reluctor with maybe a small white paint line, so you can easily spot if it ever moves out of alignment again.

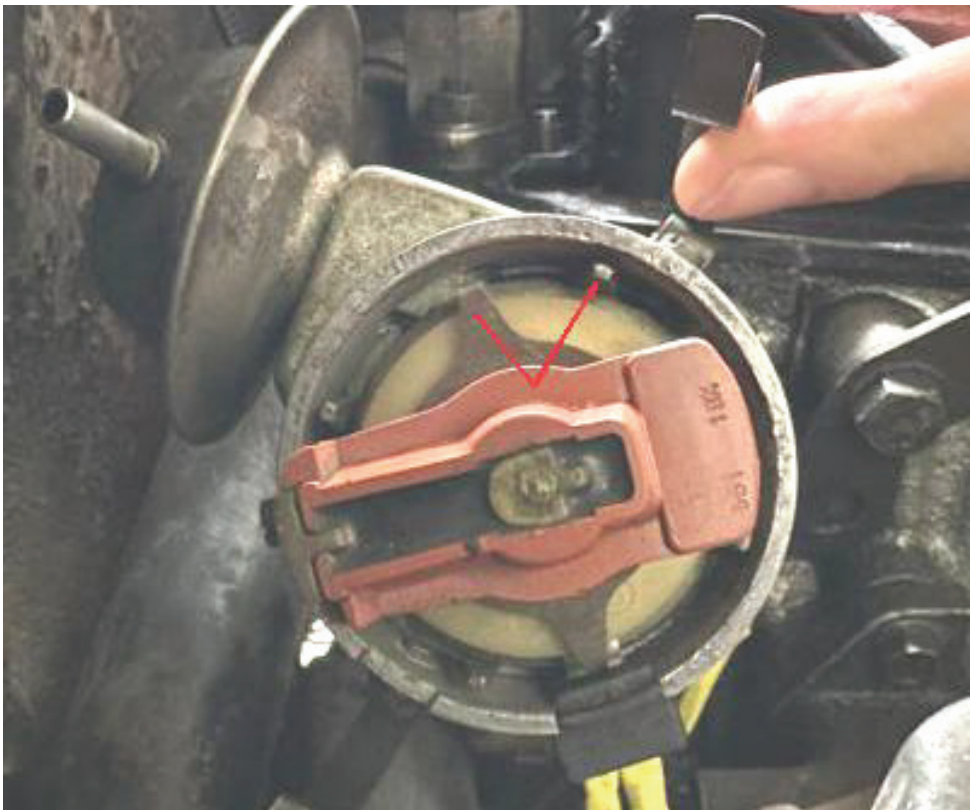
Now if that lead has ever been damaged, repaired or replaced by normal wiring, first the polarity of the connections is important, and second it really should be shielded wiring not just normal twin core wiring. If you look at the distributor picture on page 3, you will see that where the orange plug should be, there are two yellow terminals plugged onto the distributor coil pins. That means the wiring is not original and has been replaced by normal wiring, and we don't know if the correct polarity has been maintained, so that needs to be checked.

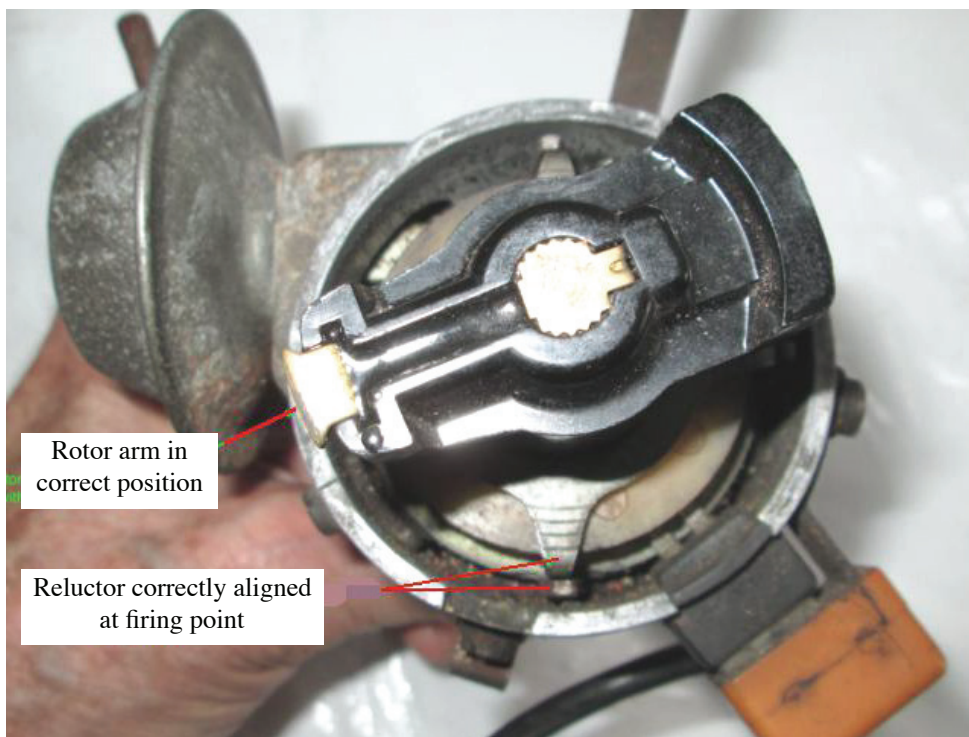
Now if you check out the photo on the next page, where the rotor arm is in approximately the same position with the tip near a distributor cap segment, the Reluctor fingers are correctly aligned with the stationary fingers triggering a spark.

In the previous page photo, the orange plug, which is held in place by its bracket screwed to the distributor body, has two terminals that connect the shielded wiring to the distributor coil. Removing the screw allows you to pull the plug away to reveal the two coil connections. Now this coil is a polarity conscious item and on the plastic housing holding the fine coil winding are marks A and B. 'A' is the positive connection and 'B' the negative. 'A' connects back to pin 5 of the ignition amplifier and 'B' connects to pin 6.

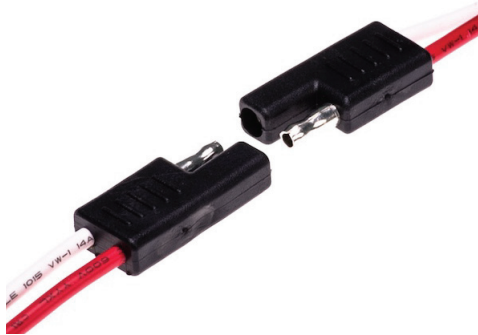
This plug is a special twin plug designed so it can only fit one way to keep the polarity correct, similar to the one in the next photo. They are sometimes known as a 'sea-dog' connector if you need to search for one.

The difference is that the two wires in this photo are separate while the wiring lead between the amplifier and distributor on the Murena is a shielded lead preventing any interference to the tiny signals passing along it and causing ignition problems. So that one lead contains two small wires with a wire mesh surrounding them, all along the length from amplifier to distributor.
