Murena *mechanics*

Head lamp pop-up system

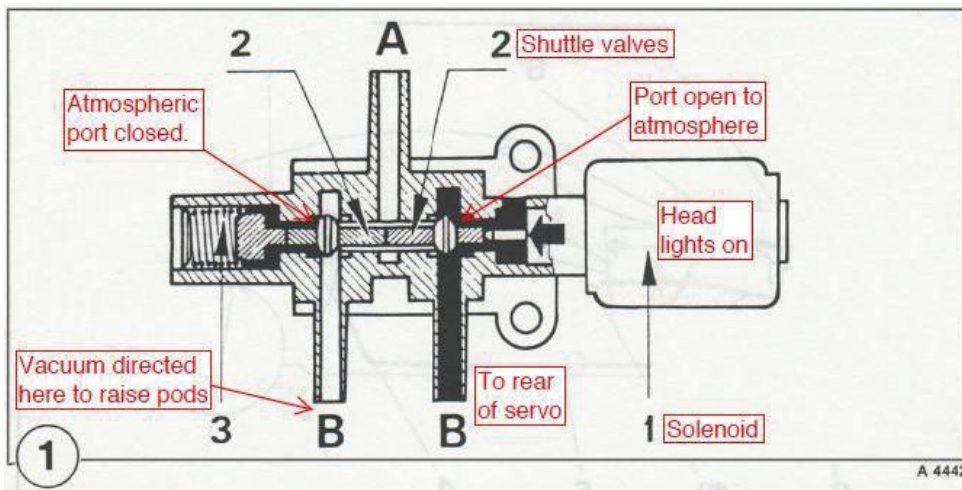
I have annotated below two diagrams from the workshop manual which should make it easier to understand how this valve should work and help you diagnose problems.

Diagram 1 shows the valve in the activated position when the head lamps are switched on. The solenoid has pushed the shuttle valves (2) to the left and the vacuum (white) is directed to the lower port furthest from the solenoid, as well as shutting off the atmospheric port. At the same time the small hole near the solenoid that allows atmospheric air (black) in, is now directed to the lower port nearest the solenoid.

The lower port nearest the solenoid is connected to the back section of the double acting servo, whilst the lower port furthest from the solenoid is connected to the front section of the servo. With atmospheric

pressure at the back, and a vacuum at the front, the diaphragm is pushed forward and the linkage raises the head lamp pods.

When the head lamps are switched off, the valve reverses the directions so the rear of the servo now has the low pressure and the front section has atmospheric pressure, so the diaphragm is pushed back pulling the pods down again. The inlet for the atmospheric air pressure now is at the opposite end to the solenoid and enters past the star clip and shuttle valve return spring.

The return spring (3) pressure exerted is important. Too much and it will try to stop the valves moving fully left when the pods need to be raised. This can cause the shuttle valve to fail to seal and the vacuum will continue to leak away and the pods will struggle to lift. It will also cause the engine to run weak with consequent power problems and since a weak mixture burns hotter, may contribute to the cracks that are experienced by these cylinder heads. Too little spring pressure and you lose valve return pressure. Therefore the depth of that star washer in the inlet port is important.

Although the workshop manual does not give a dimension for this, taking an average of all the valves I have which are known to work correctly, it appears that it should be around 4-6mm. Some later valves may have a split pin across the port, rather than a star washer, to retain the spring.

Overhauling the valve

If this valve appears to be sticking, and maybe causing the leaking, you can strip it, clean it and check its operation. Take care when removing it from the car as the two plastic mounting flanges can break, and also take care with the four long self tapping screws that hold the assembly together as they can crack the plastic body.

Have a nice clean area where you strip it, to make sure you don't lose any of the small pieces and carefully note how they all fit. The two shuttle valves are the same but only fit one way round, the longer lengths towards each other. Once it is all apart, make sure everything is dry and clean, and there must be no oil here. To lubricate the rubber seals and valves, I use a tiny amount of talcum powder! Blow off any excess.

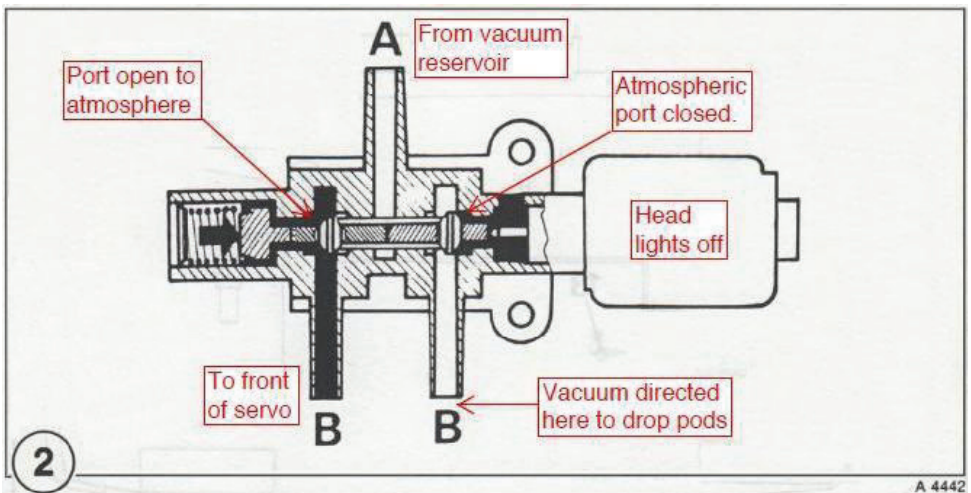
Different Solenoids†

Be aware there are two slightly different solenoids fitted to these valves. They are easy to distinguish from one another and the first visual clue is on the outside. If there is an aluminium shield around the solenoid, which is fitted to retain the centre actuating pin, then the small diameter pin inside is a plain, tight, push fit into the large diameter pin.

If there is no shield fitted, then the small end of the pin will have an 'E' clip fitted which stops the complete pin exiting the solenoid body as the hole is too small for the 'E' clip to pass through. This is why it does not require the retaining shield.

The alloy retaining shield is held by being trapped between the solenoid and valve body as they are screwed together. This means the solenoid is slightly further back by the thickness of the shield. Therefore the pin has to be slightly longer than the one with the 'E' clip, the difference being the thickness of the shield (1mm). The pin only moves 2mm, so you can see that the difference in pin length is important.

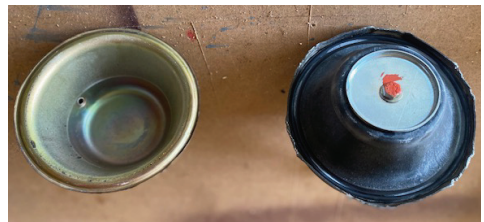
If your Murena has been unused for a lengthy period, you may find that the head lamp pods will no longer lift. In fact you cannot pull the pods up with neither the emergency cable, nor by hand, and they are completely seized in the closed position. This will not be a vacuum system fault. It will probably be because the servo has been missed during servicing and hasn't had any cleaning or lubrication; where the centre rod enters the servo, and without use, the rod has seized in the bearing.

You will have to strip the servo to free it off, so remove the servo from the car. First remove the two hose connections. The servo is held at either end with a socket snapped on to a ball. There are tiny clips fitted to prevent the sockets opening and coming off, so remove these first. Then carefully prise the sockets off the balls, and take the servo to the bench.

You must not attempt to rotate the rod to free it, because it is bolted to the diaphragm which is held around the casing circumference, so rotating the centre rod would rip the diaphragm.

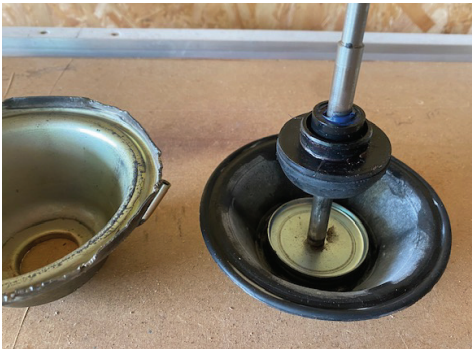
The two halves of the servo casing are crimped together, so you have to unbend these to separate the two halves. You could do this a few ways depending on what tools you have, but bear in mind you will need to re-crimp it afterwards, so mark the two halves for re-alignment.

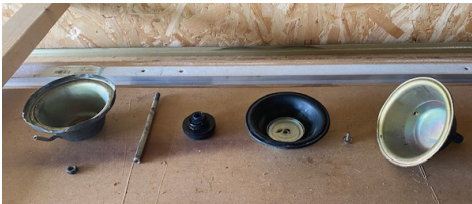
Once the two halves are apart, you need to hold the rod securely without damaging it, so you can undo the centre bolt, to separate the rod from the diaphragm. One suggestion is to grip it in a cordless drill keyless chuck. Then you can see if you can free off the rod from the bearing by hand.

Using some freeing agent, try to rotate the bearing back and forth just using your hand. Hopefully, it will free off, then use more lubricant and holding the bearing with your hand, try slowing rotating the rod with the drill. If you can get it revolving freely, then you can separate them to clean and check for any surface damage.

Assuming these are still good, the servo can now be re-assembled using some grease to lubricate the rod and bearing. After bolting the rod back to the diaphragm, you should re-assemble the two halves of the casing, making sure to align them as they were before it was stripped, and re-crimp them together, then check for air leaks.
