Murena *mechanics*

Radiator Matrix Protection

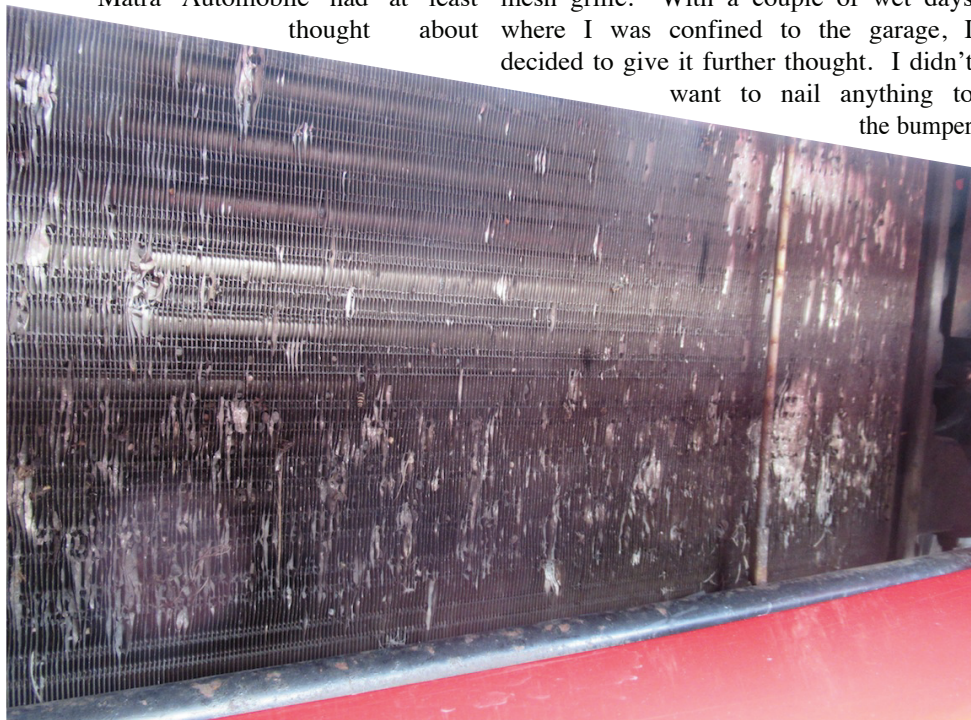
Having had a radiator damaged beyond repair some years ago and the replacement now looking decidedly tatty, (*photo below*) I have often pondered about how to fit a mesh grille. With a couple of wet days where I was confined to the garage, I decided to give it further thought. I didn't

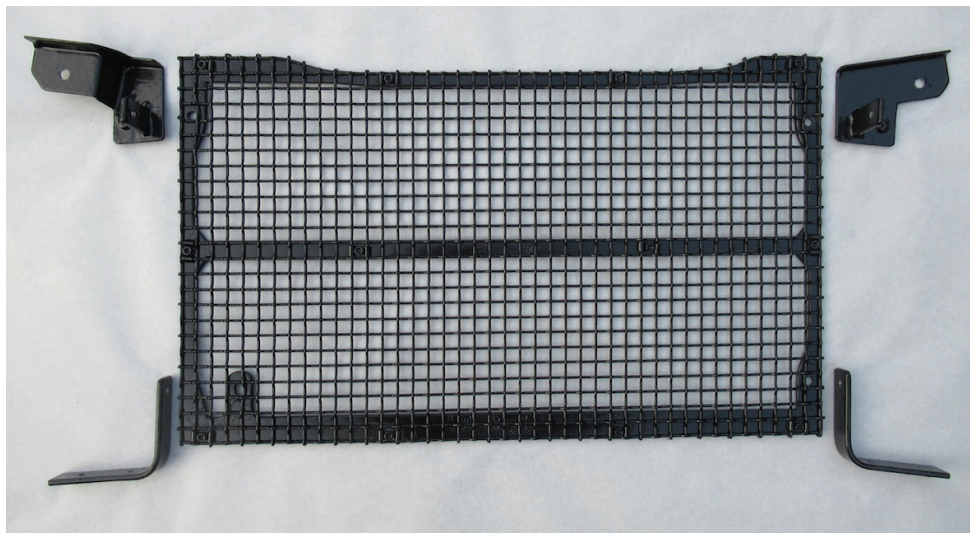
they have a huge range from which to choose. The mesh was attached using twelve s.s. clips and M4 cap head socket screws, tapped into the frame. The upper brackets were fabricated from 2mm mild steel sheet. The upper and lower brackets were tapped to accept M6 s.s. screws. The photo below shows the grille and the mounting brackets, and the photo at the top of the next page is a closer view of the brackets. The photo below it shows the new s.s. deflector plate, fitted with the lower grille mounting brackets.

The grille and frame and the upper mounting brackets are not symmetrical as the radiator is slightly offset to the right hand side. In addition, the top of the grille frame dips in the middle to clear the bonnet catch cover plate.

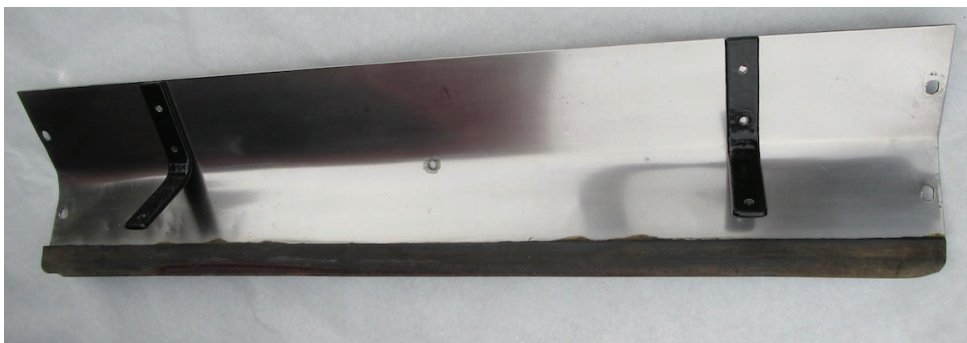
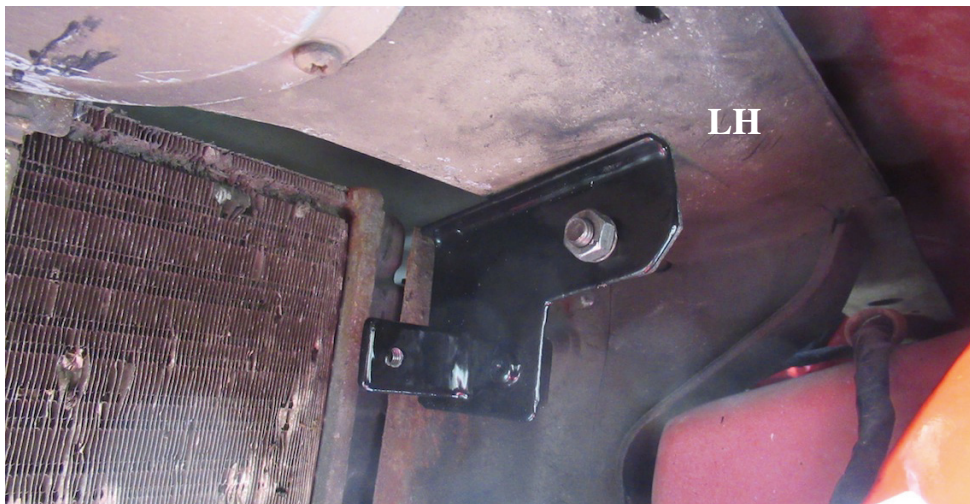
The Top Brackets In Place

The photos on the next page show the left hand and right hand upper brackets in position, respectively. The picture at the top of page 5 illustrates the grille in place, with the horn refitted to the LH bracket. The photo below it, shows the lower

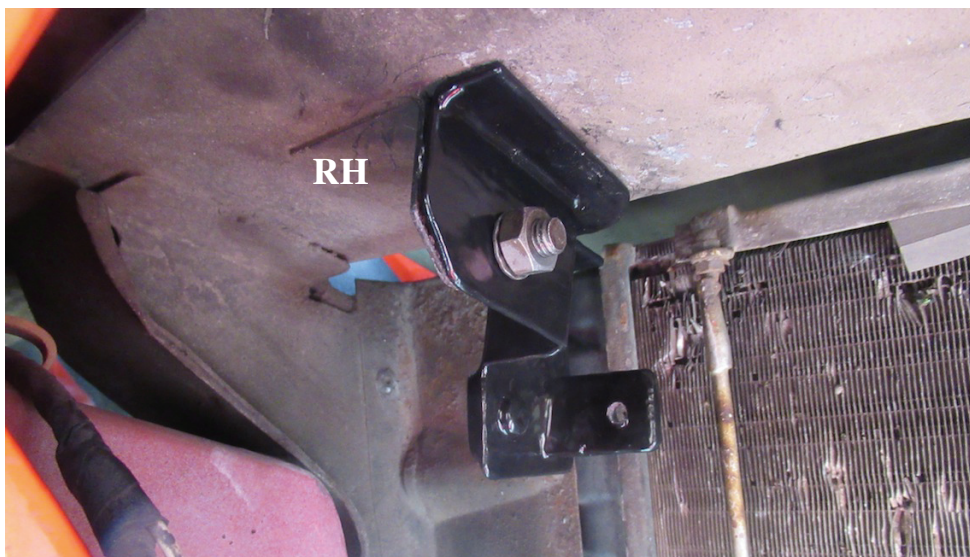
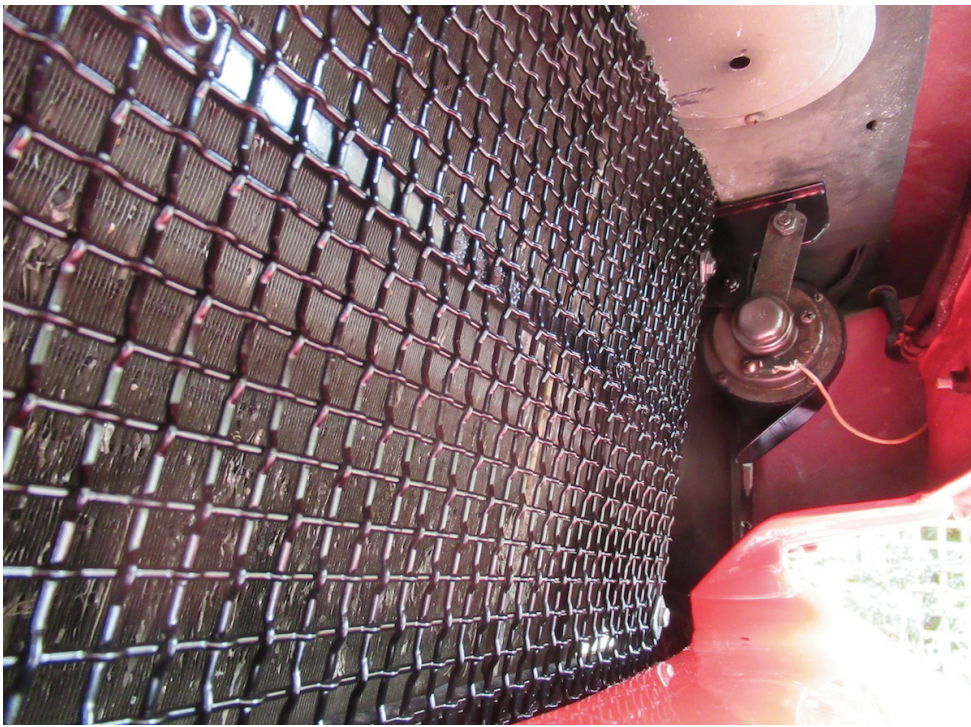
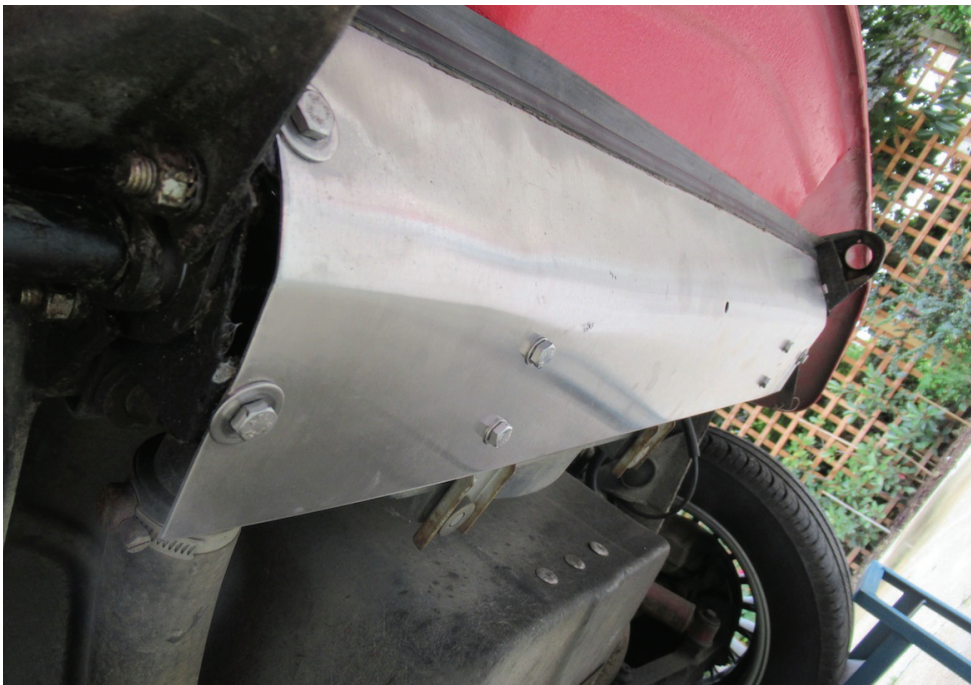
radiator deflector plate from below. The final photo on page 6 shows how the bottom of the grille fits between the bumper moulding and the headlight cross tube.
