# Murena *mechanics*

## **Ignition System Resistor**

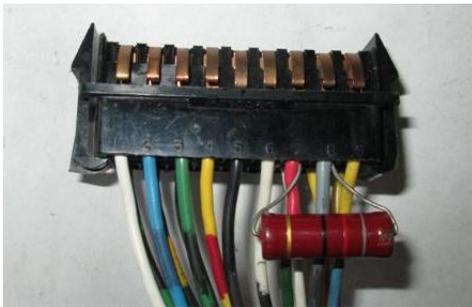
possibly cause a fire. Commonly the bulbs are now capless type 1.2w bulbs. These are fine for general illumination or the other warning lights but their current flow is insufficient for energising the alternators used. The manufacturer has therefore wired a resistor in parallel with the bulb to provide the necessary current. Both must be connected and in working order if your charging system is to energize properly.

It is this resistor that causes the slightly different ignition warning light effect since as you turn on the ignition, some of the current flows through the resistor as well as the bulb and therefore the bulb is slower to achieve its full brightness.

So what is the reason for this anomalous behaviour? Well, if any owner has had the instrument panel out, they should have seen that there is a resistor wired across the warning light connections, at the back of the plug that fits into the instrument panel. Why is it there? What is it for? Unfortunately, I have never seen or found any explanation in the workshop manual or amongst the Matra literature for this fitting,

This resistor is shown on the original factory master wiring diagrams, but it was missing in the workshop manual and consequently I never found it on any of the early copies that became available.
