Murena *mechanics*

Ignition System Resistor

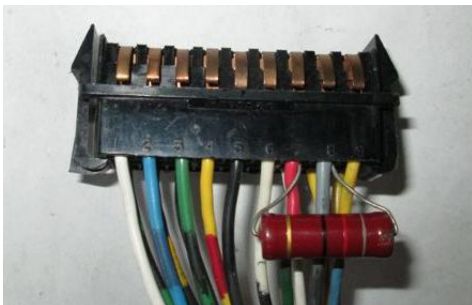
Recently though, with the advent of smaller instruments and therefore smaller warning lights, the bulb sizes have also dropped. This means that their wattage has reduced too. The heat generated by a 3w bulb would probably be too much for the close surroundings in these compact instrument panels and would melt the plastic and

possibly cause a fire. Commonly the bulbs are now capless type 1.2w bulbs. These are fine for general illumination or the other warning lights but their current flow is insufficient for energising the alternators used. The manufacturer has therefore wired a resistor in parallel with the bulb to provide the necessary current. Both must be connected and in working order if your charging system is to energize properly.

It is this resistor that causes the slightly different ignition warning light effect since as you turn on the ignition, some of the current flows through the resistor as well as the bulb and therefore the bulb is slower to achieve its full brightness.

So what is the reason for this anomalous behaviour? Well, if any owner has had the instrument panel out, they should have seen that there is a resistor wired across the warning light connections, at the back of the plug that fits into the instrument panel. Why is it there? What is it for? Unfortunately, I have never seen or found any explanation in the workshop manual or amongst the Matra literature for this fitting,

This resistor is shown on the original factory master wiring diagrams, but it was missing in the workshop manual and consequently I never found it on any of the early copies that became available.
